# Hillsborough Bridge Structural Review

## Final Report

142613.00 • Final Report • January 2016

Prepared for:  
**Prince Edward  
Island Department  
of Transportation  
and Infrastructure  
Renewal**

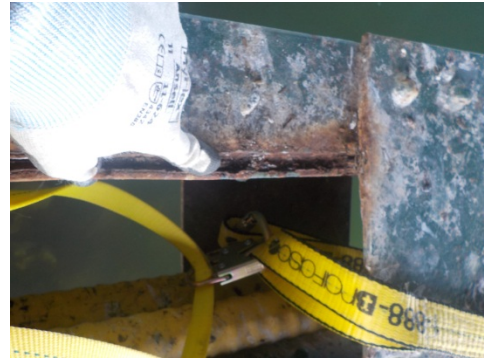
**Photo 3.1: Typical Corrosion at Channel/Web Plate Edge**

Locations with web plates typically exhibited corrosion at the exposed interface of the channel webs and web plates (**Photo 3.1**). This amount of section loss is not considered to be critical in determining the member capacity.

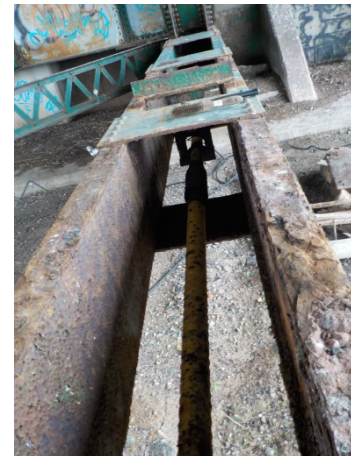
The top flange from L39 to L37 (**Photo 3.2**) on the right truss was severely corroded and was found to have approximately 30% section loss on the top flanges and approximately 15% section loss in the webs. This section loss will be considered in the resistance calculations. At the same location the connection of the post tensioned ducts (L37) appeared to have corrosion in the welded connection (**Photo 3.3**). Access was limited to this connection, but a 15% loss in capacity will be assumed.

**Photo 3.2: Severe Corrosion of Bottom Chords from L39-L37 Right**

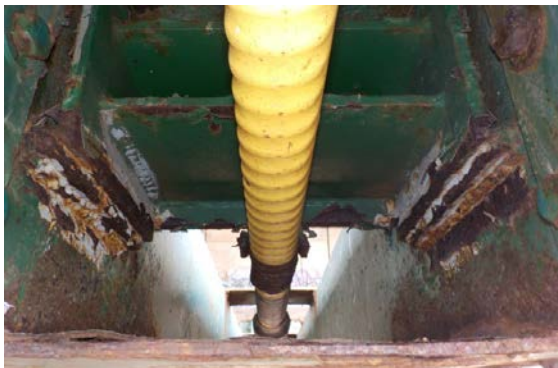
**Photo 3.3: Corroded Anchorage of Post Tensioned Reinforcing at L37 Right.**

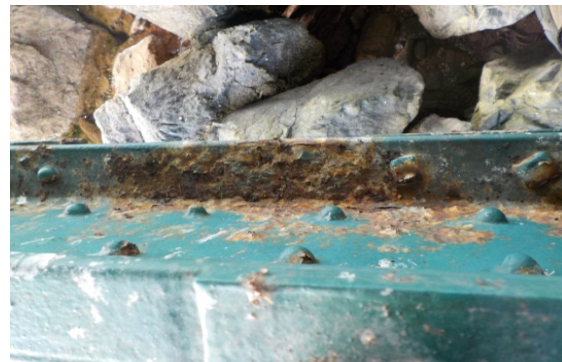
Approximately 5% section loss was observed in the bottom chord at the bottom flange and web of L2-L3 left (**Photo 3.4**). This is a localized area and will be considered if deemed critical during the evaluation.

**Photo 3.4: Corrosion of the Exterior Bottom Flange at Bottom Chord from L2-L3 Left**

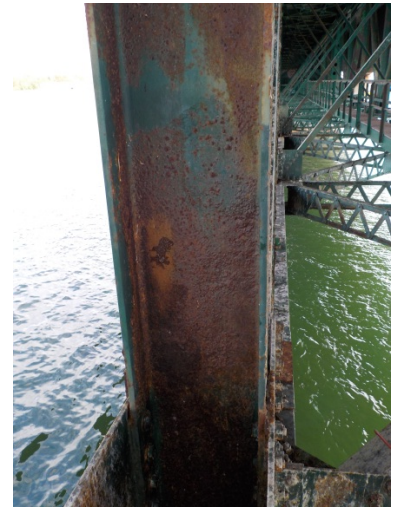
Vertical U16-L16 left exhibited approximately 5-10% section loss on the web and flanges (**Photo 3.5**) as did U8-L8 right. Other minor areas of corrosion were noted at U8-L8 left, U2-L2 left and U14-L14 right.

**Photo 3.5: Corrosion of Webs and Flanges of Vertical at U16-L16 Left**

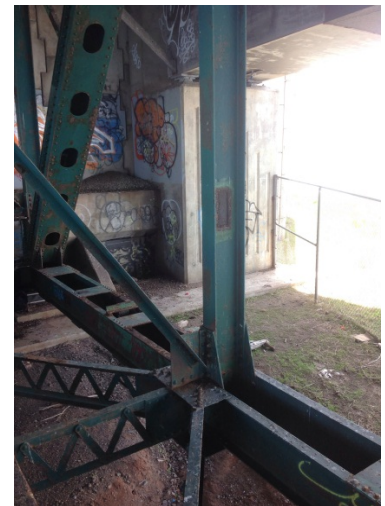
A steel coupon appears to have been taken from U37-L37 right and the patch is exhibiting lightning corrosion less than 5% (**Photo 3.6**).

**Photo 3.6: Coupon Taken from Vertical at U37-L37 Right**

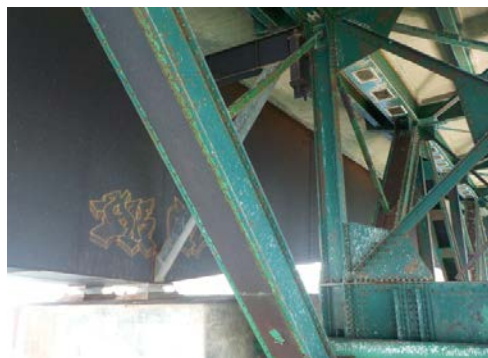
In general light corrosion was found throughout. The coatings would typically be in poor condition, specifically on the new cover plates, where the patina of the weathering steel is preventing durability of the coating (**Photo 3.7**). The appearance of the member is much worse than the actual section loss.

New intermediate diagonals were added at several locations. From a distance coating flaking was observed and a section loss of 5% was assumed (**Photo 3.7**).

**Photo 3.7: Typical Flaking of Coating on Cover Plates**

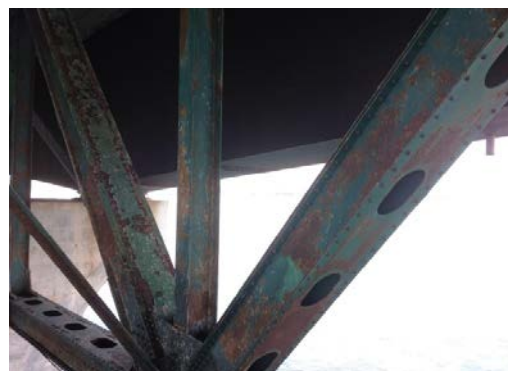
Diagonal U13-U14 left exhibited the worst corrosion at approximately 5% (see **Photo 3.8**).

**Photo 3.8: Corrosion on Diagonal U13-L14 Left**

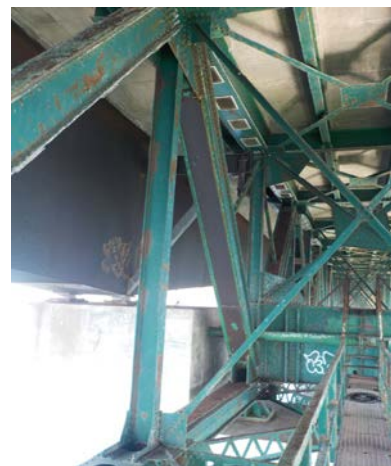
From the truss catwalk a limited inspection of the top chords was performed (**Photo 3.9**). Light corrosion was observed throughout but there were no areas of section loss of note to be considered in the evaluation. This correlates well with the 2012 OSIM inspection.

**Photo 3.9: Limited View of Top Chord from Access Platform**

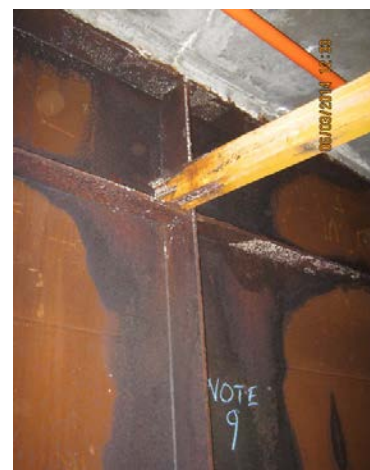
From inside the box girders transverse cracking was noticed in the deck soffit throughout. There were many locations where the cracks had been injected with sealant. It is understood that this remediation occurred immediately after the deck construction during the Bridge Widening project. A detailed inspection of the deck top was not performed as the 2012 OSIM Inspection reported it to be in good to excellent condition.

**Photo 3.10: Medium Corrosion and Staining Near Cracks in Deck**

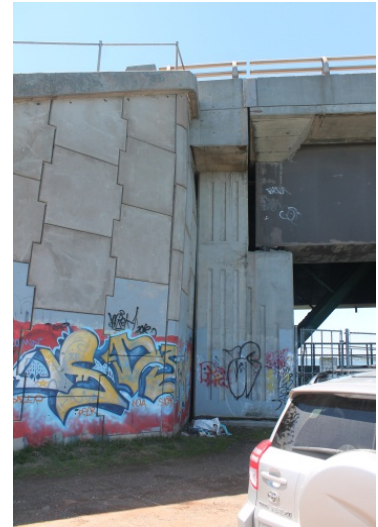
It was noticed that the MSE wall on the Stratford side (Abutment 2) appears to be bulging outward at mid-height (**Photo 3.11**). CBCL understands that, outside of this study, the original wall manufacturer will be providing an assessment report to PEITIR regarding the movement noted in the abutments.

**Photo 3.11: Apparent Bulge of MSE Wall at Stratford Abutment**

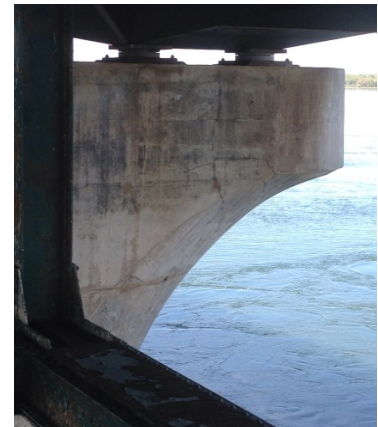
From the surface the piers appear in fair to good condition. Somewhat conspicuous are the medium vertical cracks found underneath the box girders in the flared corbel portion of the pier (**Photo 3.12**). While the size of cracks does not indicate a strength issue, durability may be of concern in this heavily reinforced and post tensioned location.

**Photo 3.12: Medium Vertical Cracks at Flared Corbel, Typical**

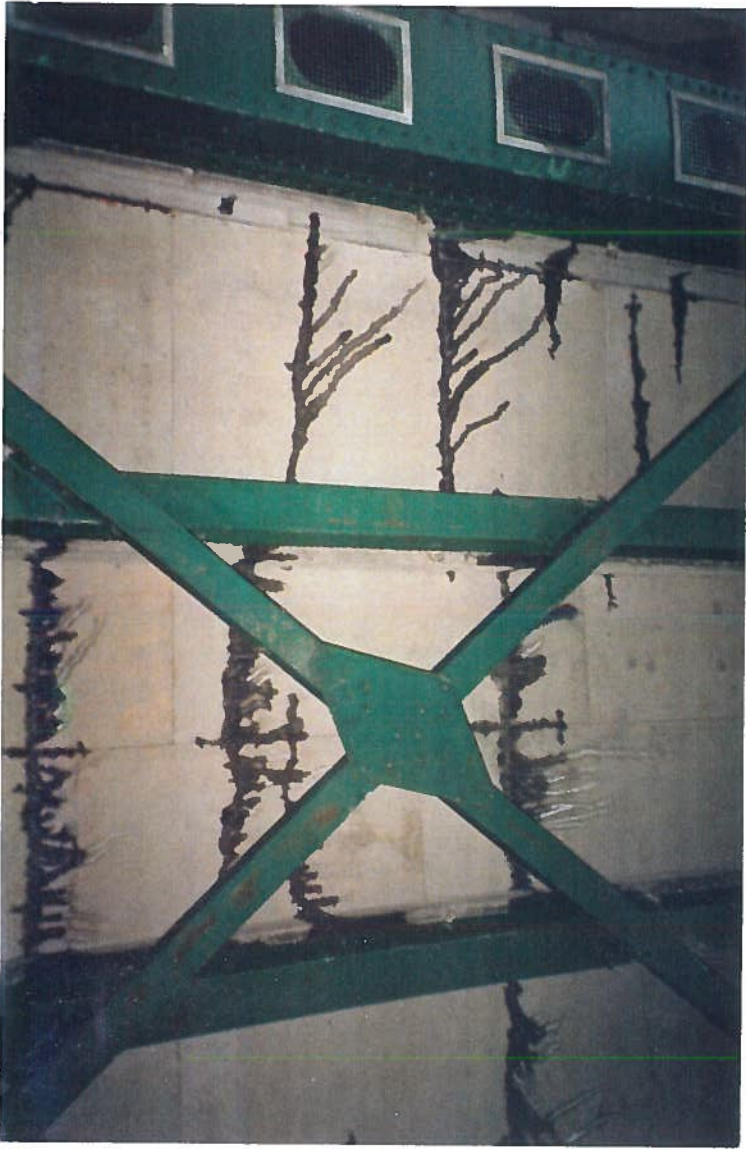
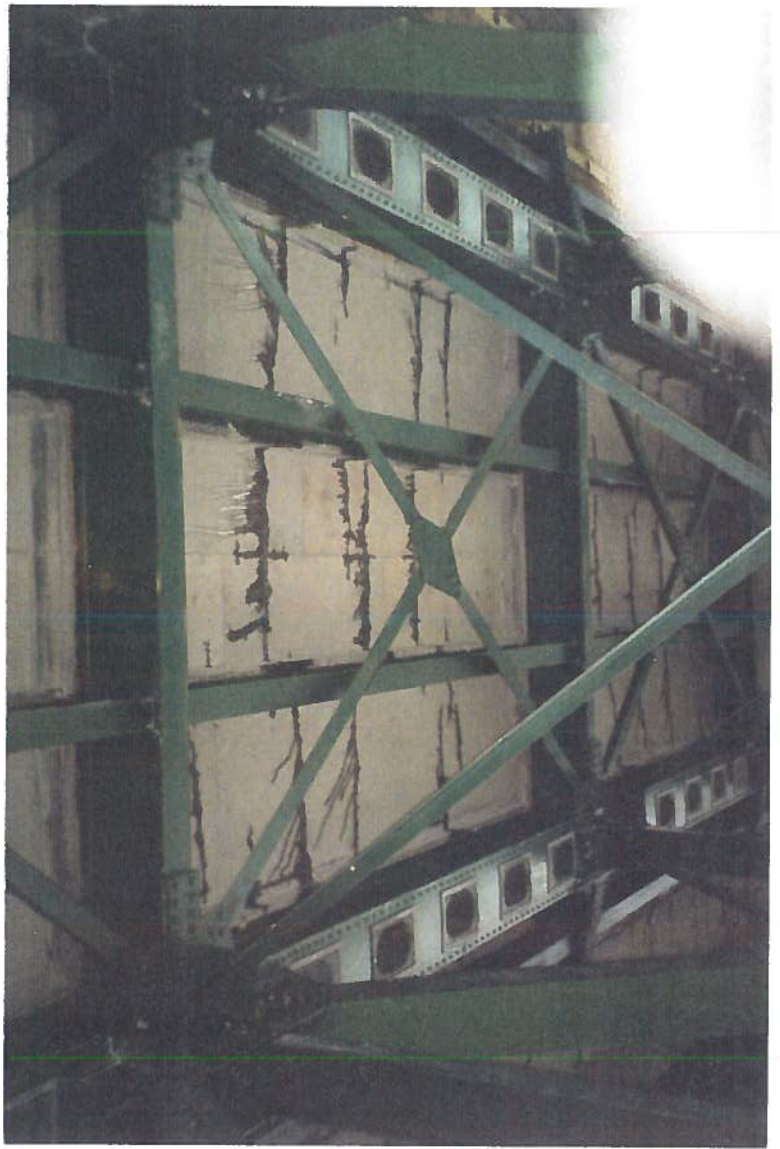
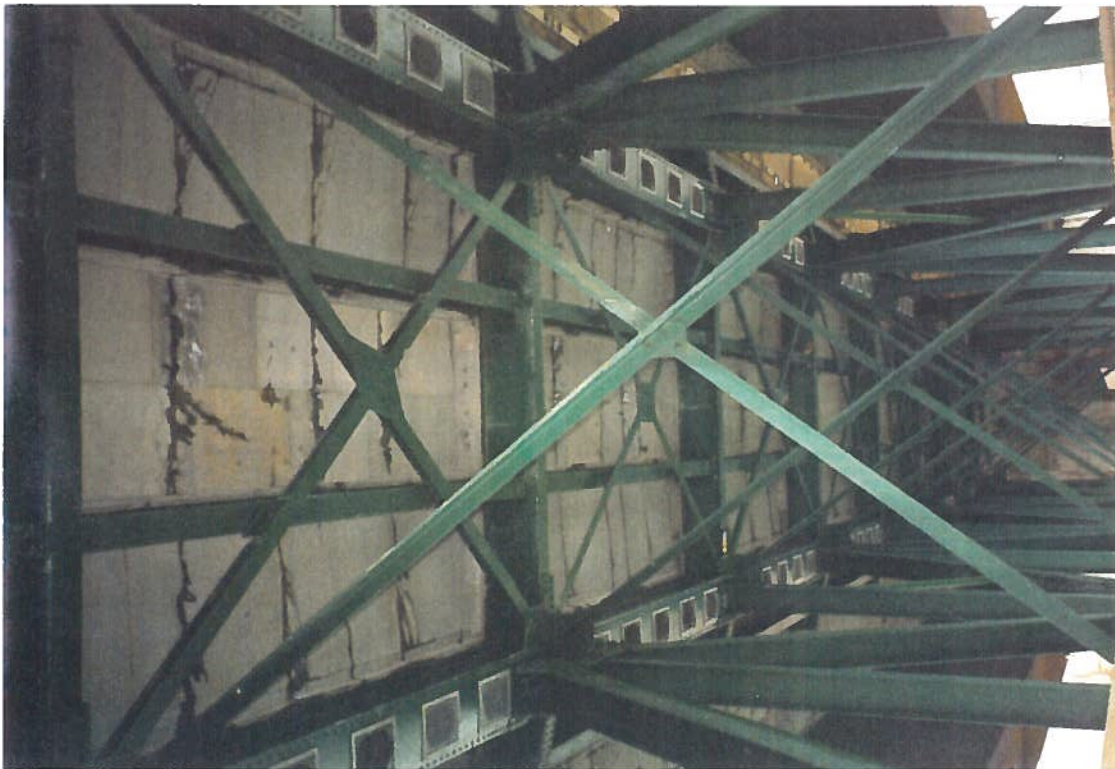
Cracks in cast-in-place  
deck-slab.

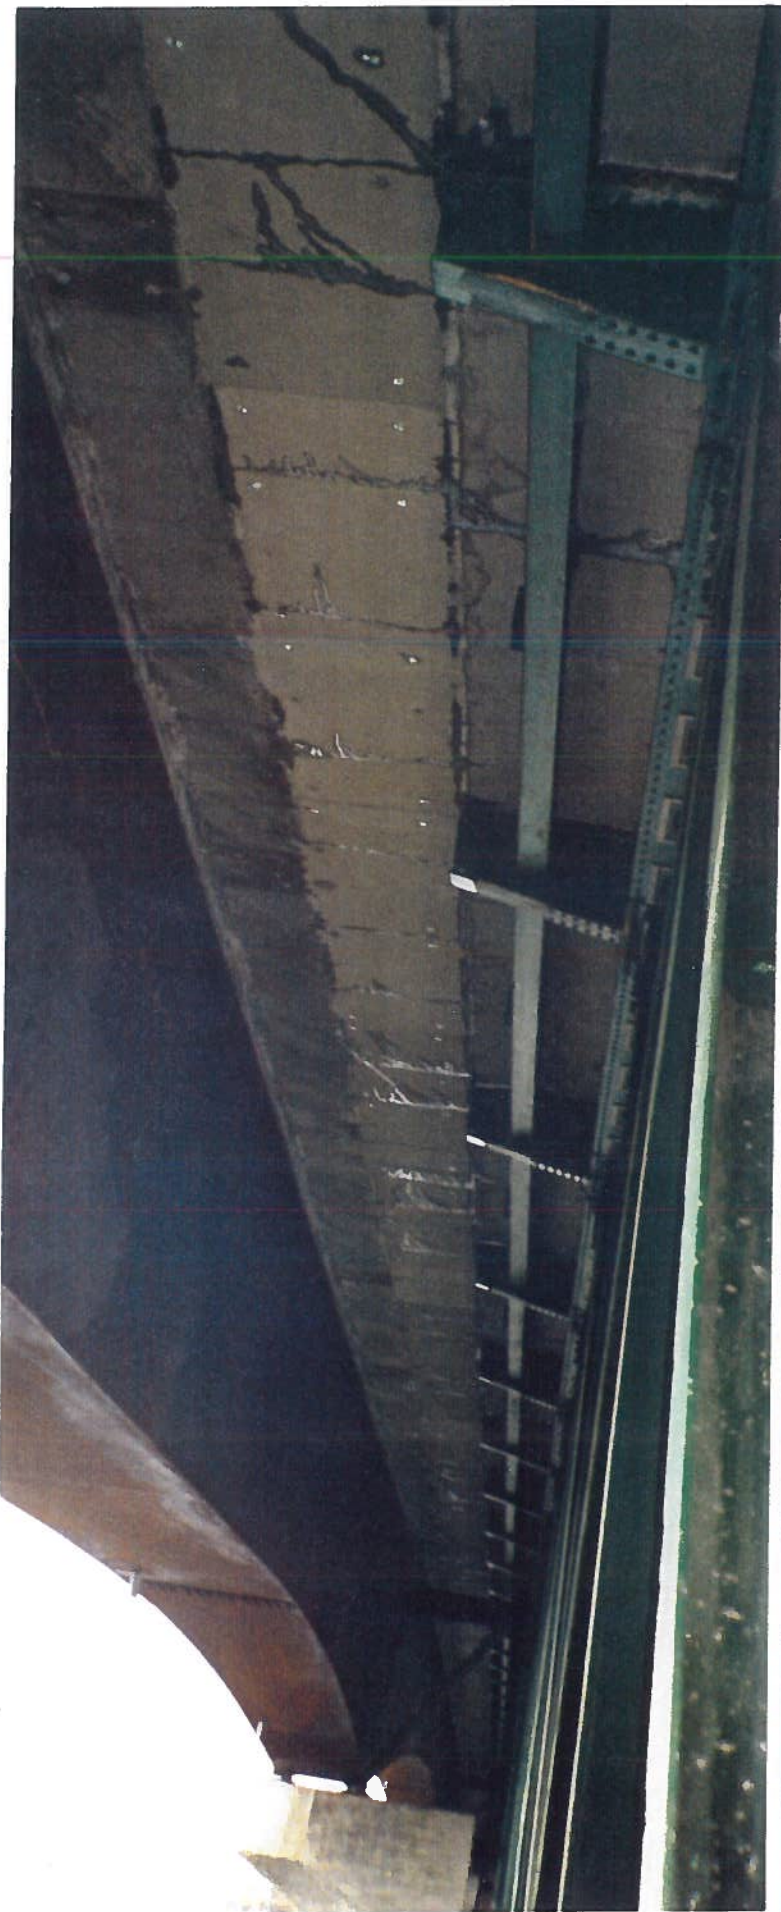
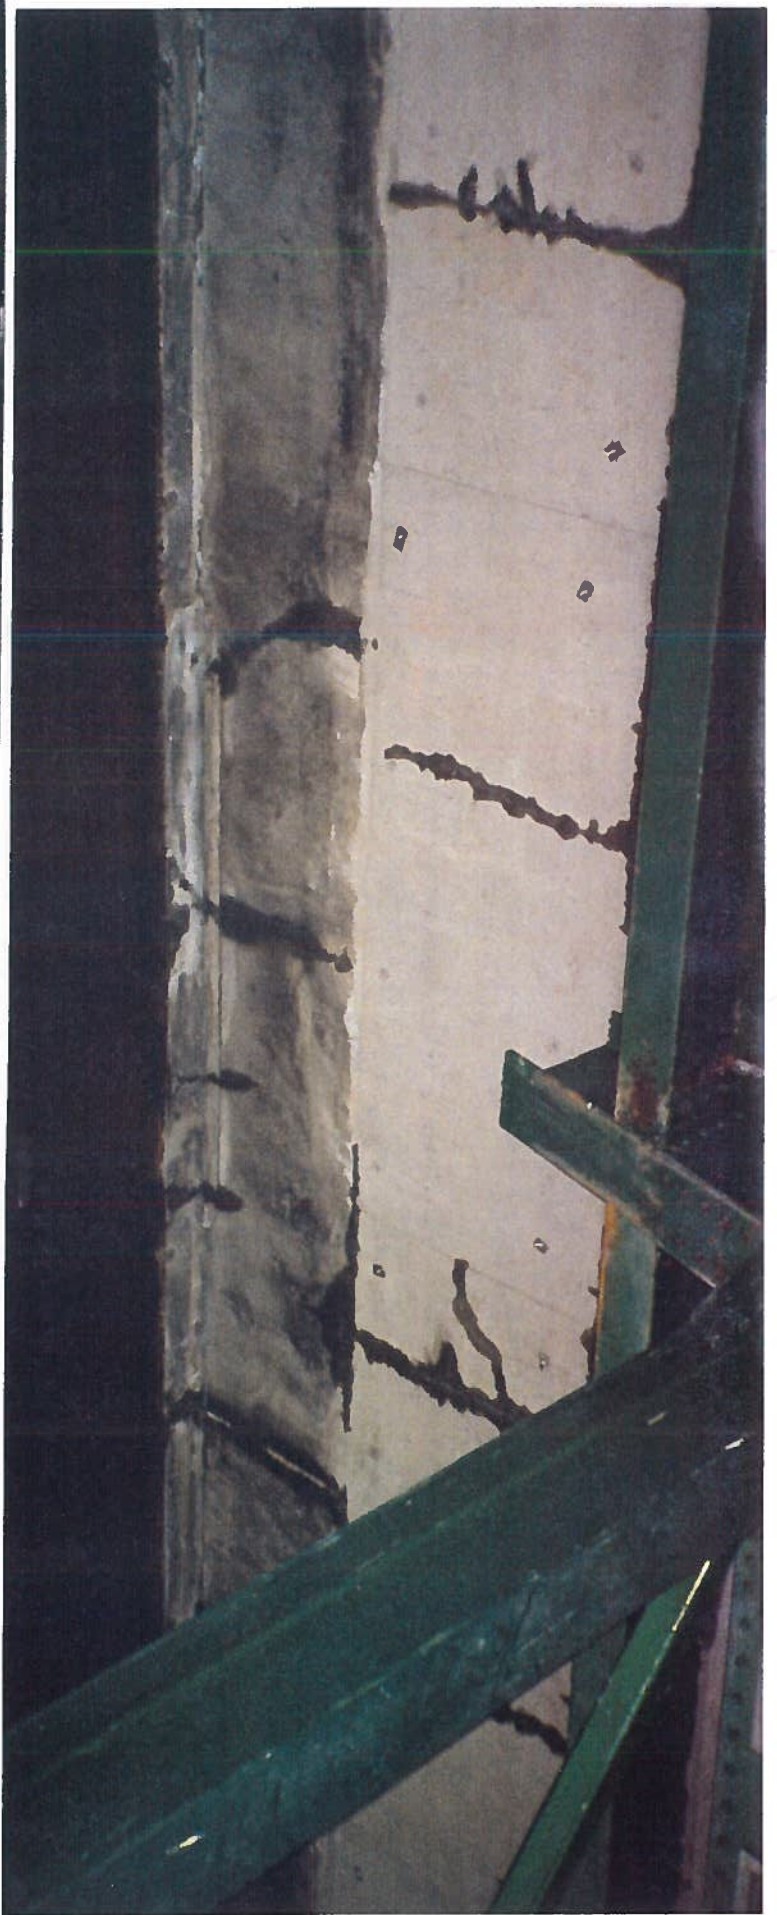
Cracks in in-fill strips.

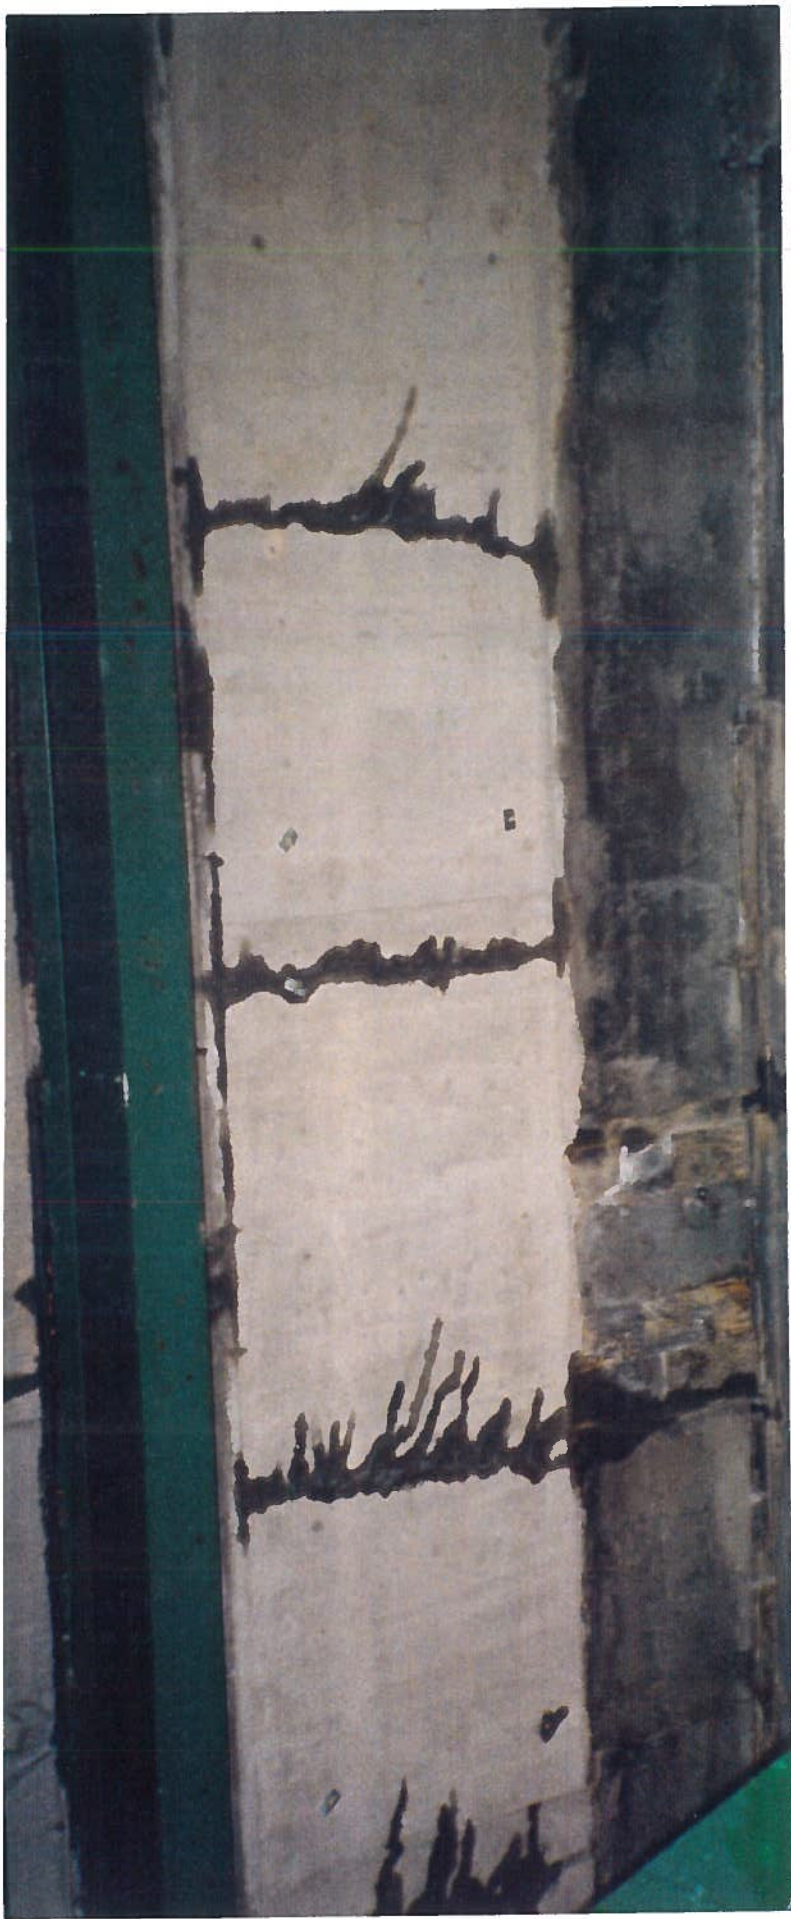
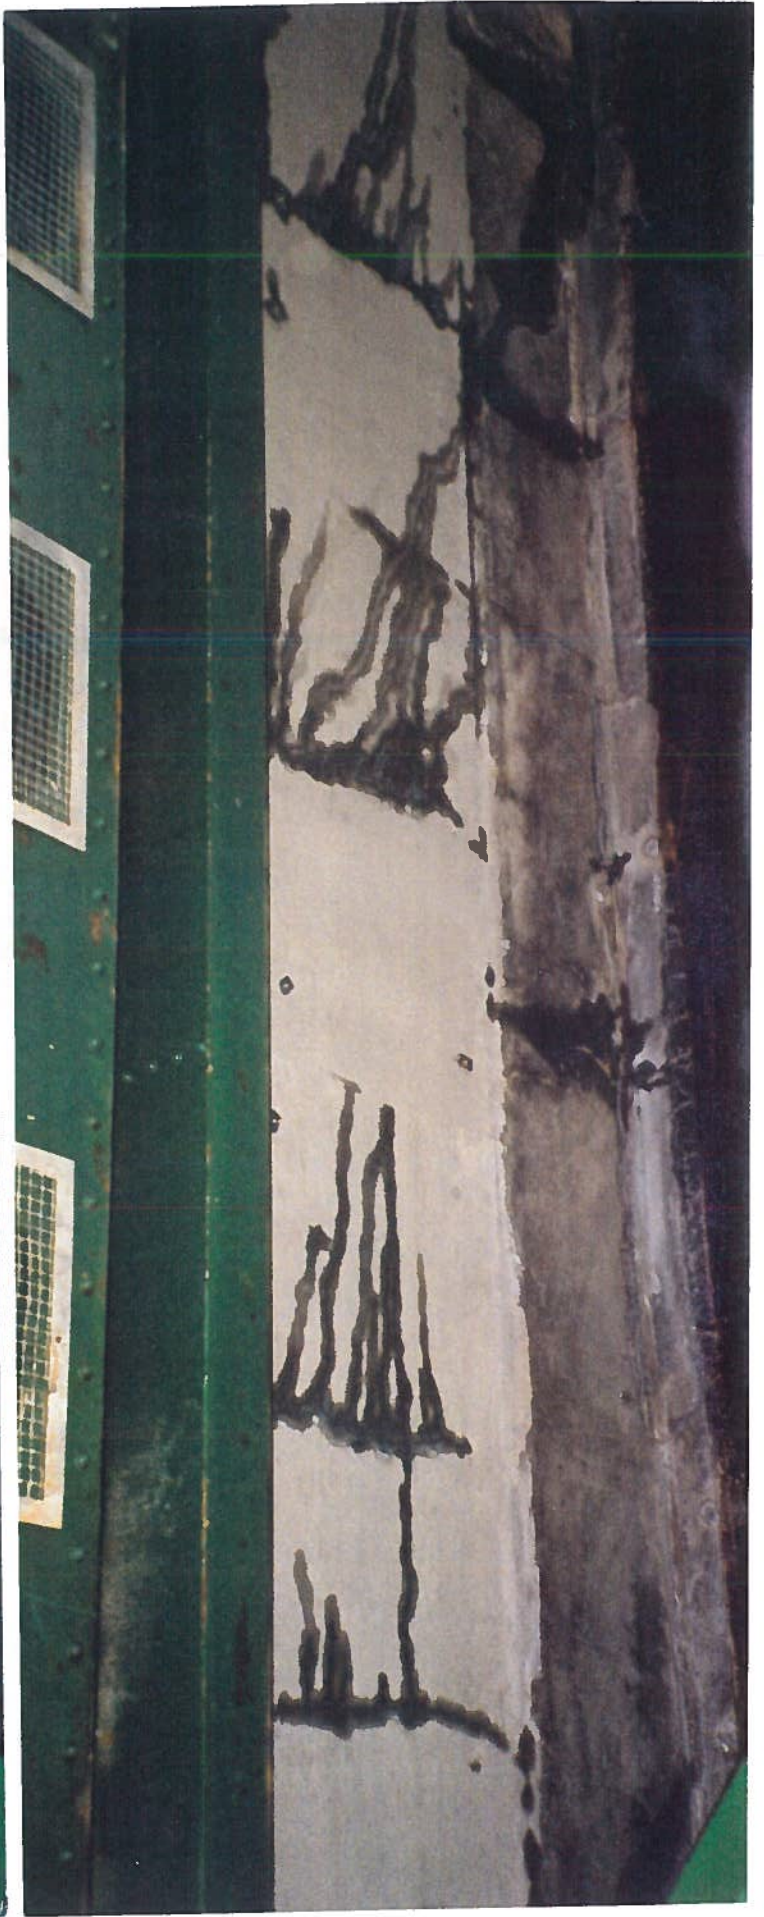
Cracks in in-fill strips

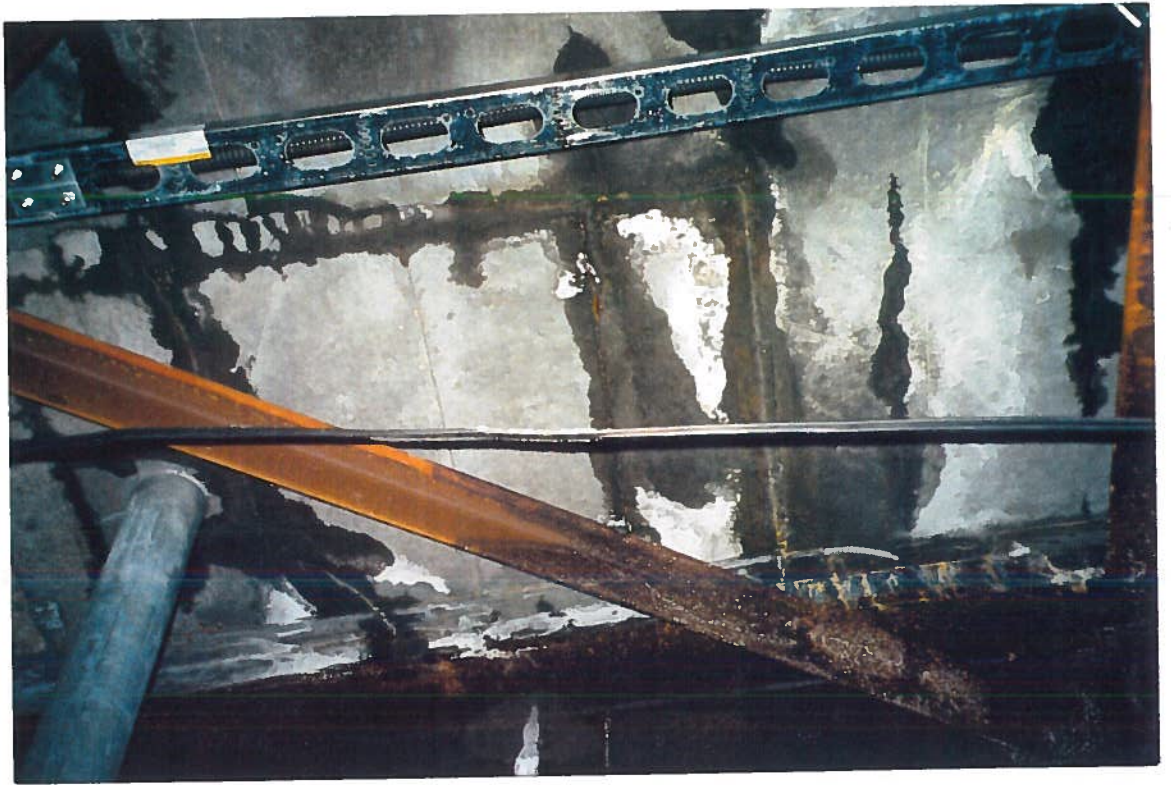
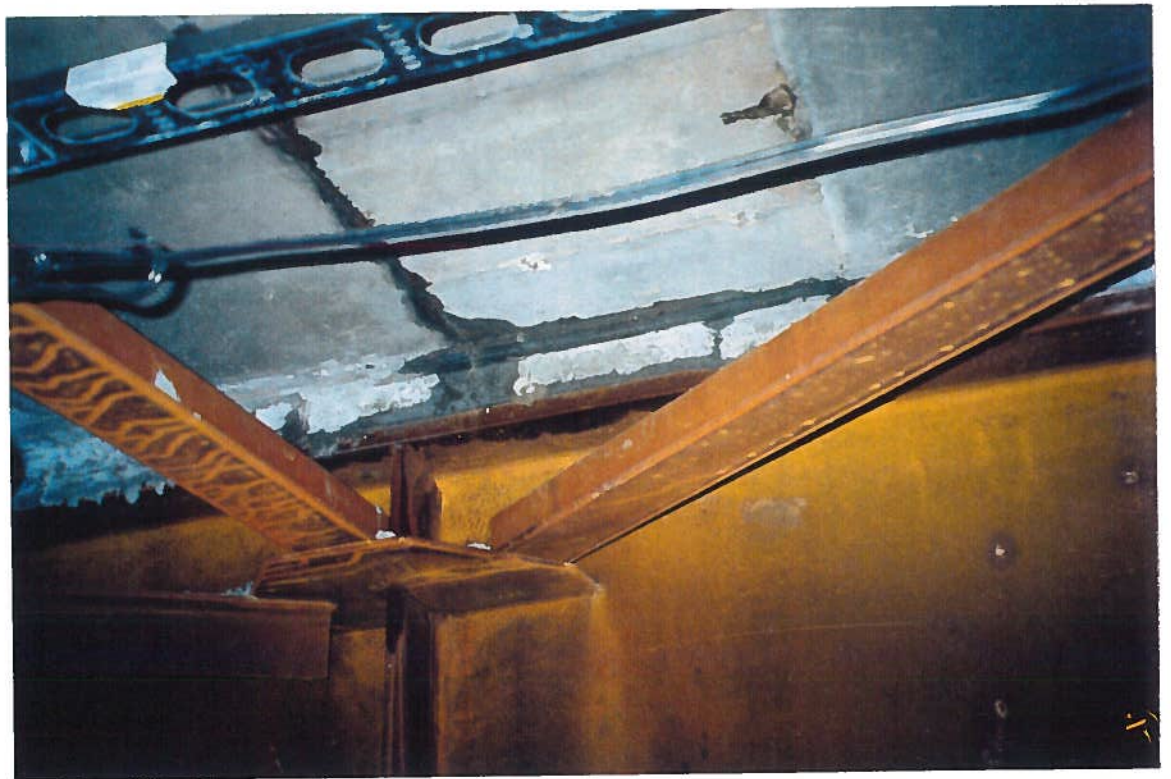
Cracks in precast panels at joints

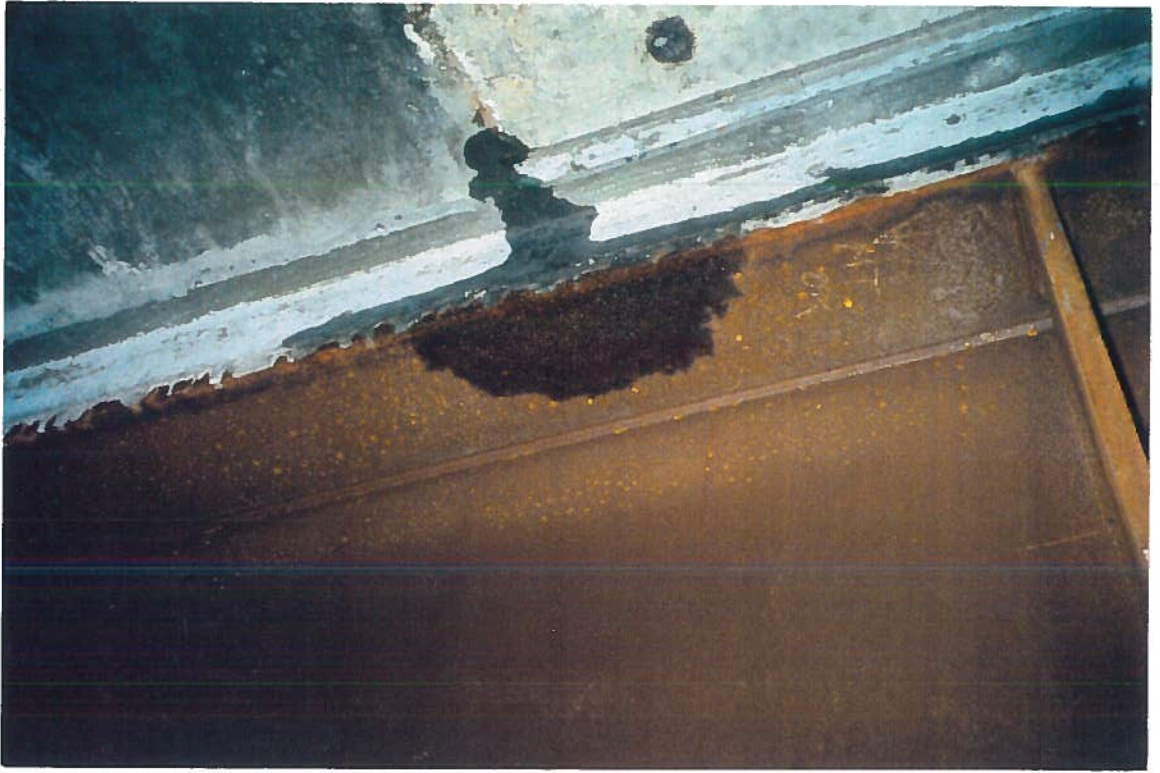
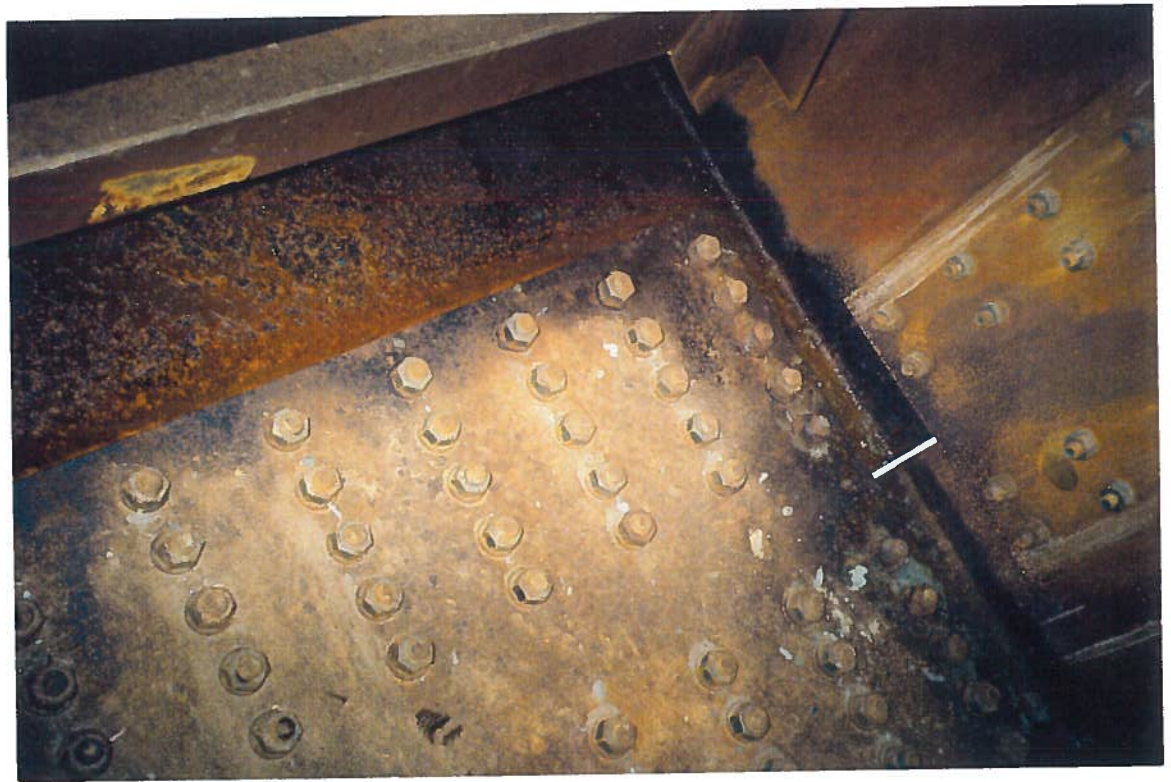
Water at curb face and interior of box

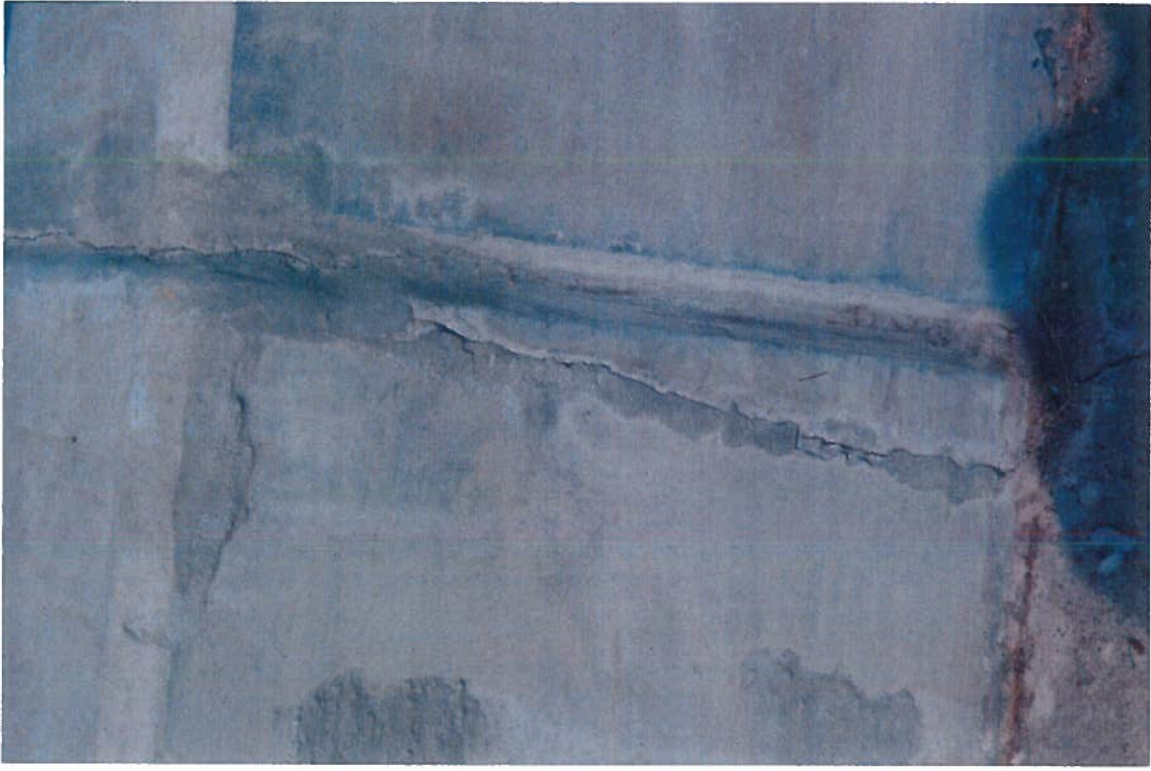
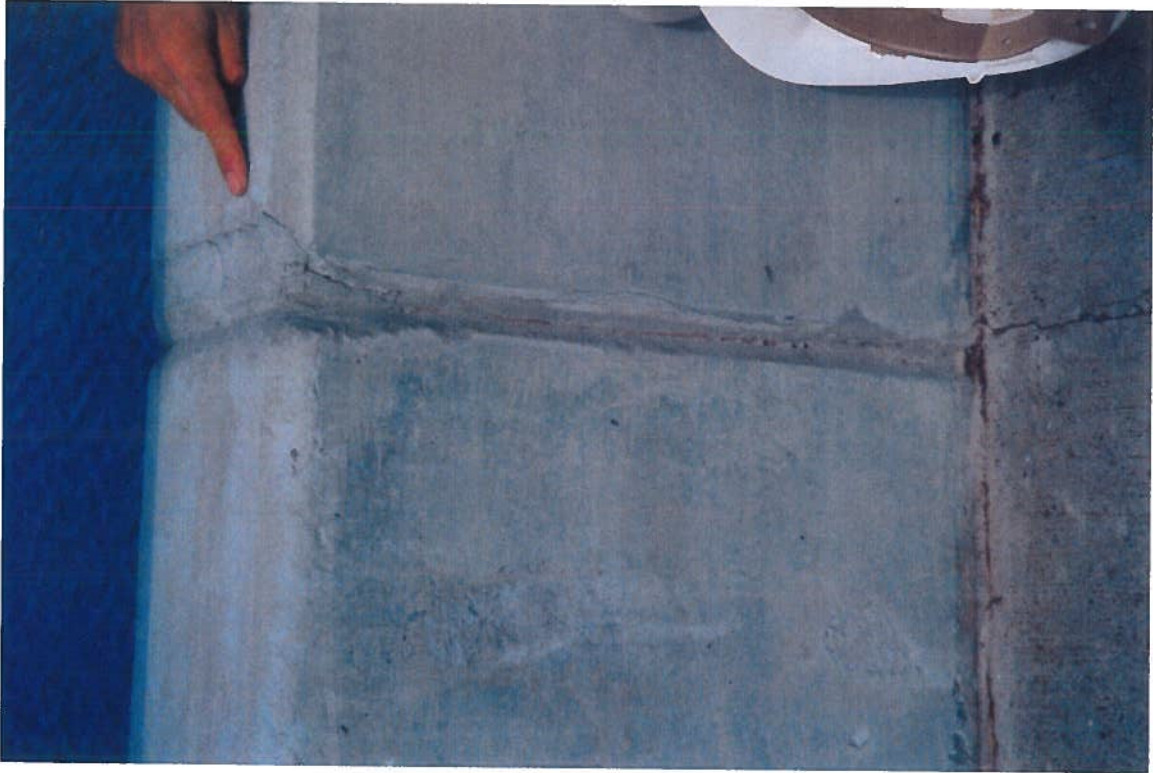
Cracks in parapet close to joints.

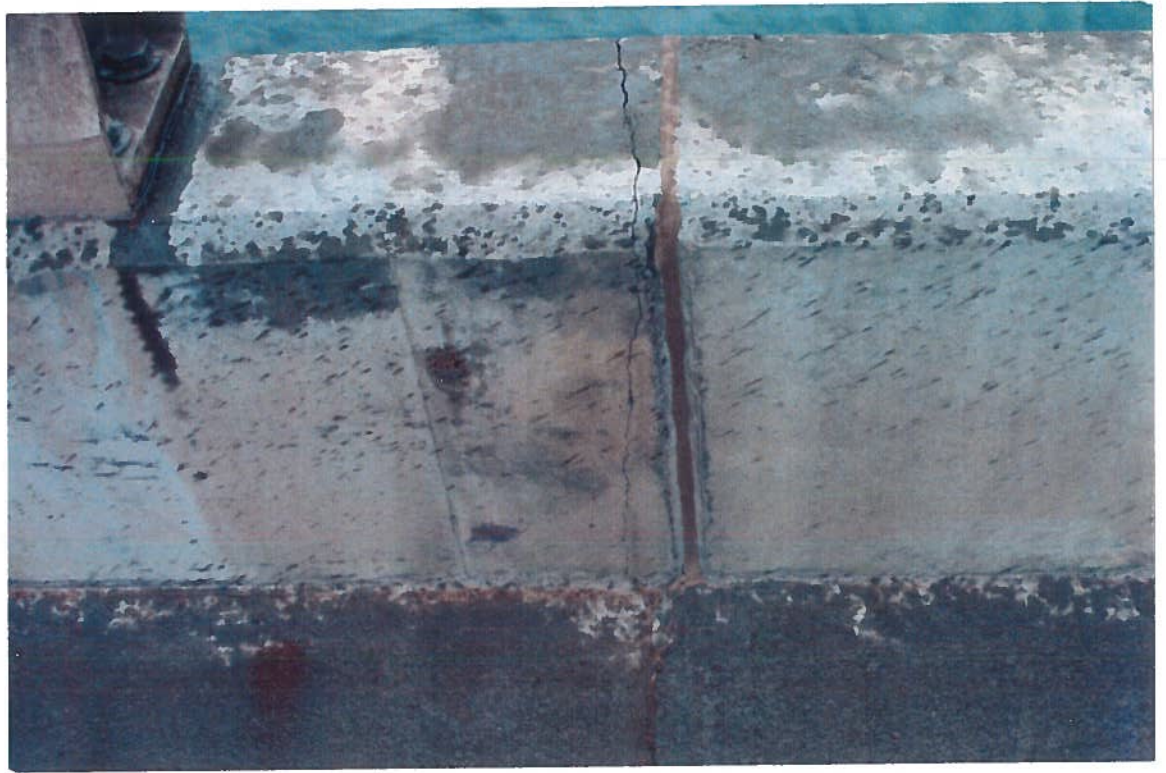
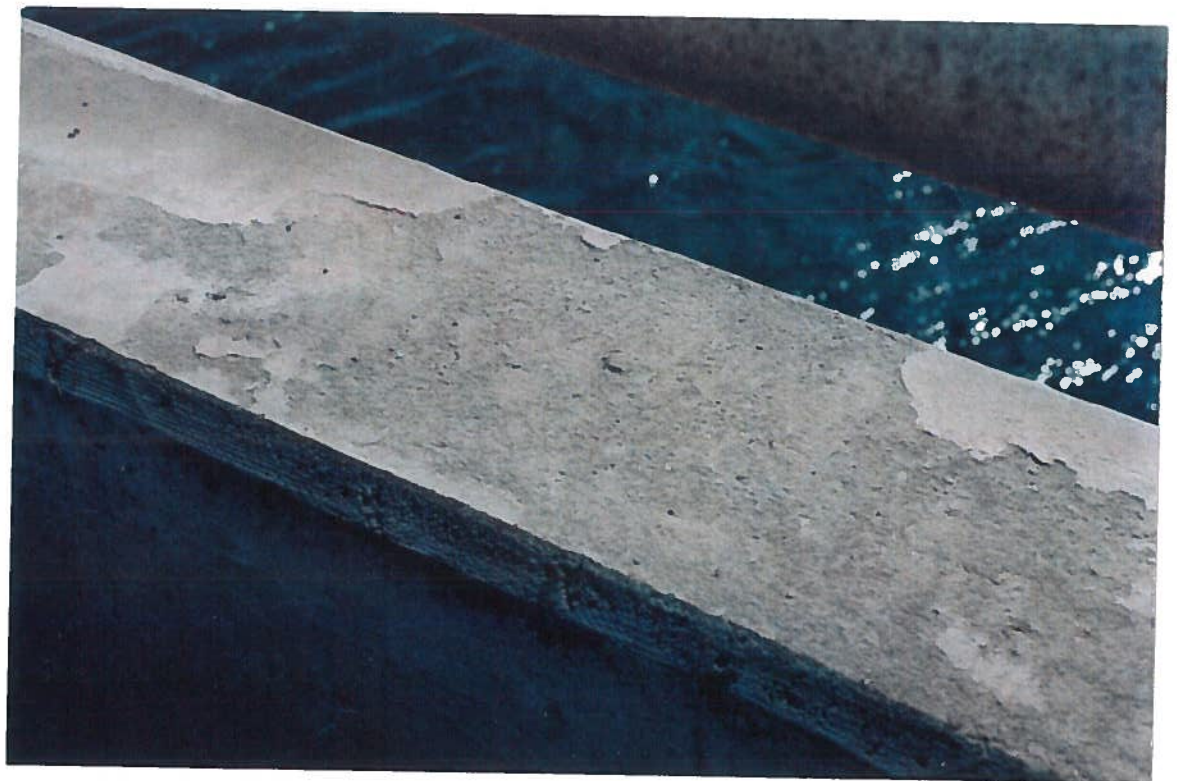
*Crack near joint and poor finishing.*

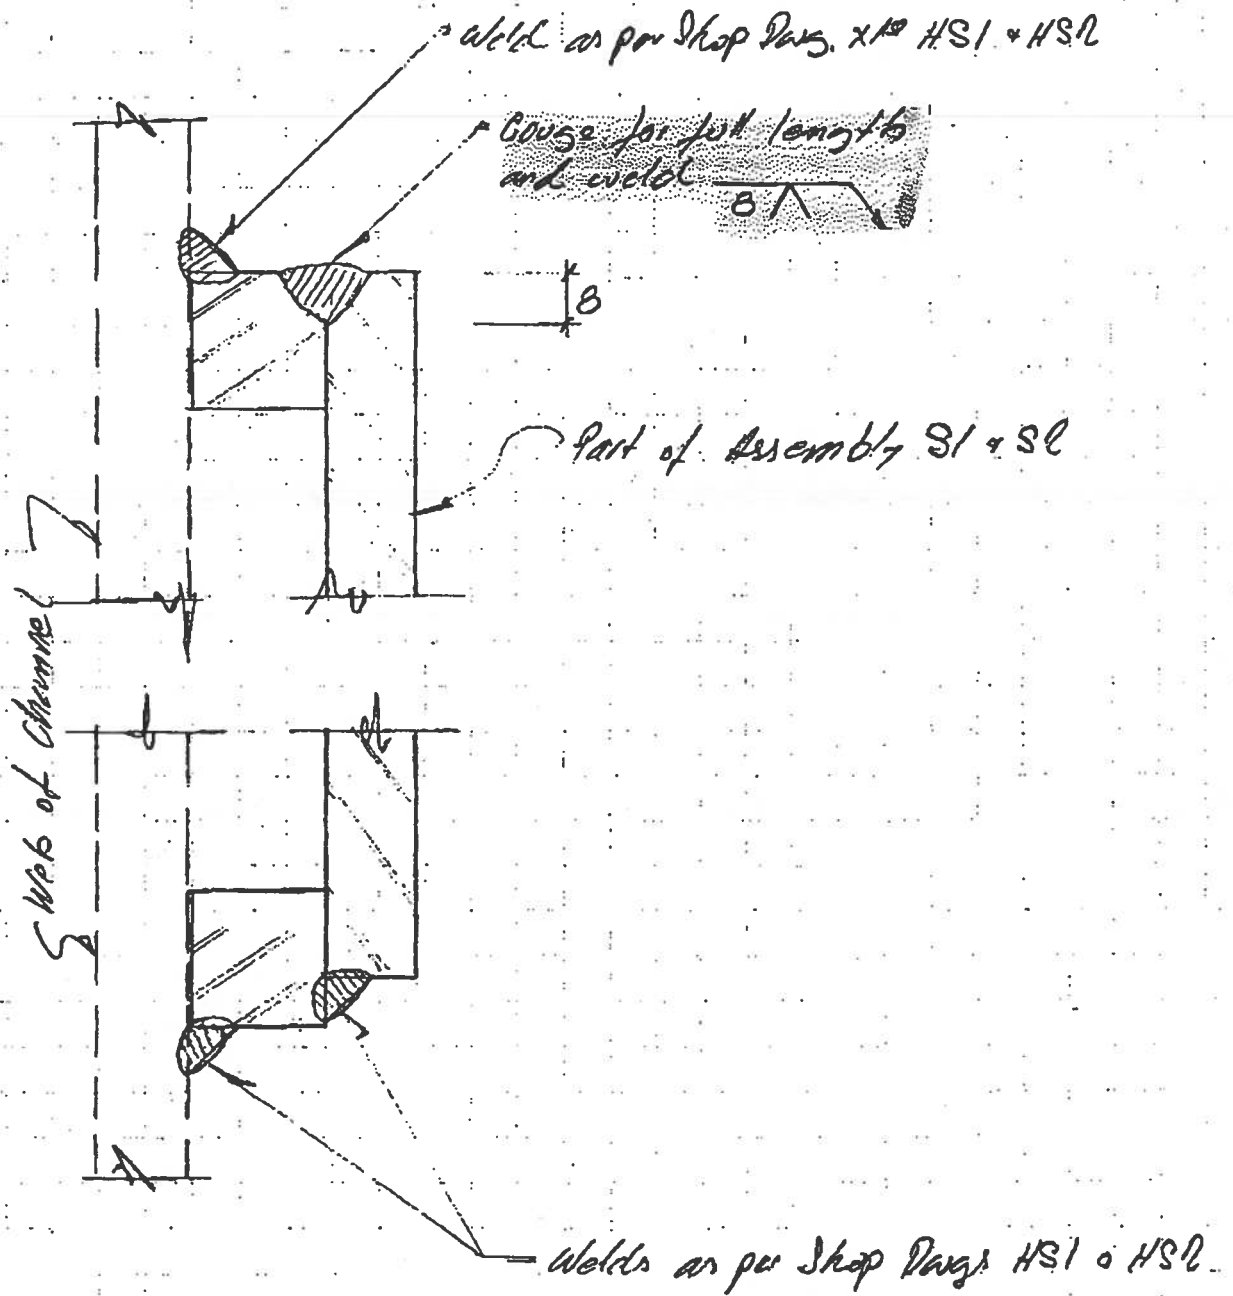
Attachment of Assembly S1 and S2  
to Bottom Chord Channels

- Welding of Dywidag anchor assemblies to the bottom chord members of the truss is not in accordance with the shop drawings. The existing tack welds (spacer bar to anchor assembly) will require modification. Refer to facsimile transmittal of 17 November 1997, copy attached.
- At a number of locations the new reinforcing plates on the diagonals do not extend sufficiently into the gusset plate joints. Plates are to extend 200 mm into the joint as agreed on site, 11 September 1997, copy attached.
- The coverplate with saddle (refer to detail 5/25 on drawing 25 and shop drawing HS4) as installed is of insufficient size to cover the slotted hole at the bottom of the vertical truss members. Additional plating will be required.
- Caulking between the existing perforated plates on the diagonals and the new reinforcing plates is to be examined at all such locations to ensure a complete seal.

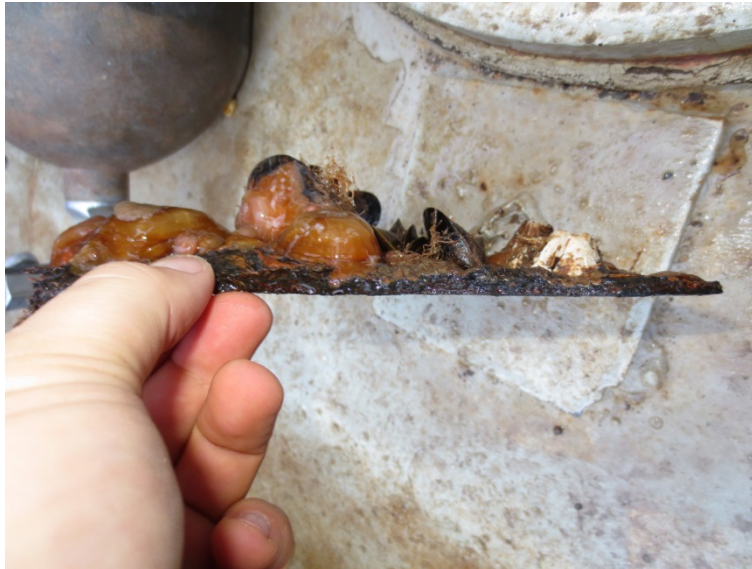
There was marine growth on all of the SSP with the heaviest growth at the sea floor and becoming less dense at higher elevations. There was evidence of Microbiologically Induced Corrosion (MIC) throughout both piers. This is characterized by a bright orange, iron rich layer followed by a dense black layer followed by bright and shiny steel surface underneath (see Photo 1 below) and subsequent pitting of the steel. The MIC ranged from 3 mm to 6 mm thick (orange and black layers combined). As shown in the tables above, the most severe corrosion rate measured on both piers was 0.36mm/year but on average it was around 0.15 to 0.20 mm/year. The worst corrosion was on the east and west faces of Pier 3 at the top of transfer cap SSP which is in the anodic zone. The anodic zone is typically within 1.0 or 1.5 m below the low water mark.

**Photo 1: Piece of MIC brought to surface.**

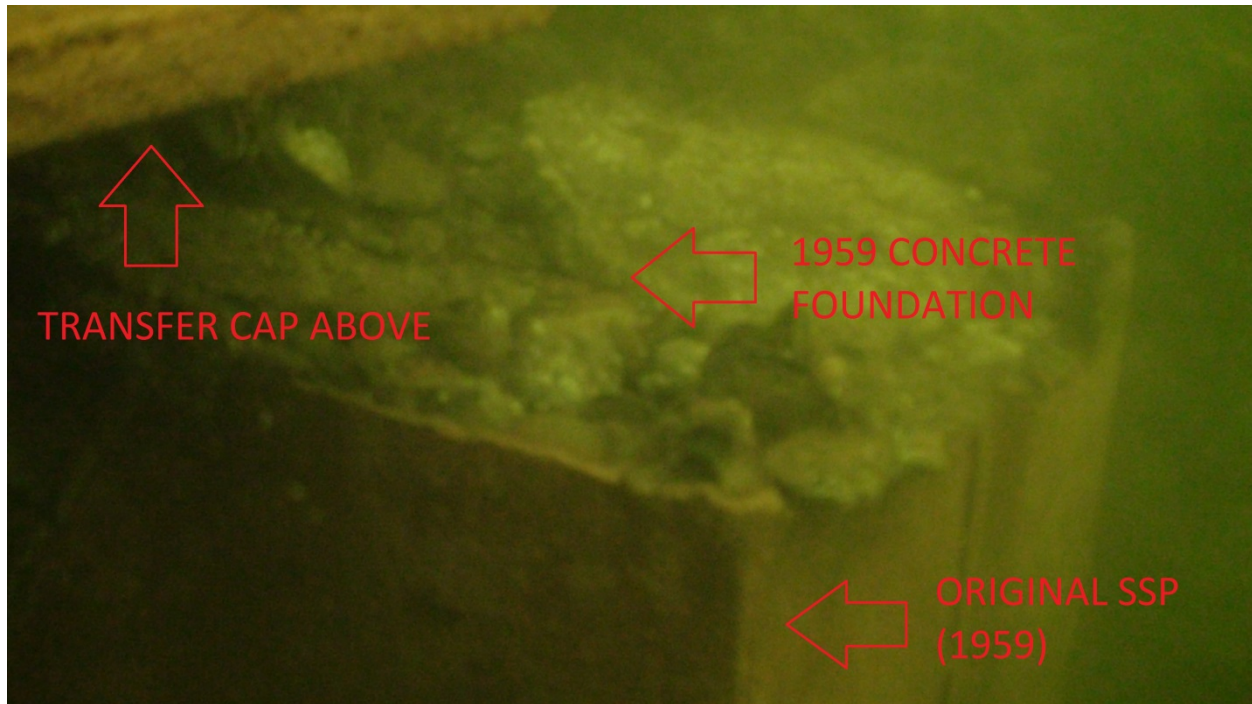
The ledge between the original SSP and the transfer cap has localized spalling in certain areas but is generally in a good condition state. The spalling appears to be adjacent to the original SSP. The concrete appeared to be heavily scaled but considering its age, this would be expected. See Photo 2 below.

**Photo 2: Typical condition of original concrete foundation.**
