# Hillsborough Bridge Structural Review

## Final Report

142613.00 • Final Report • January 2016

Prepared for:  
**Prince Edward  
Island Department  
of Transportation  
and Infrastructure  
Renewal**

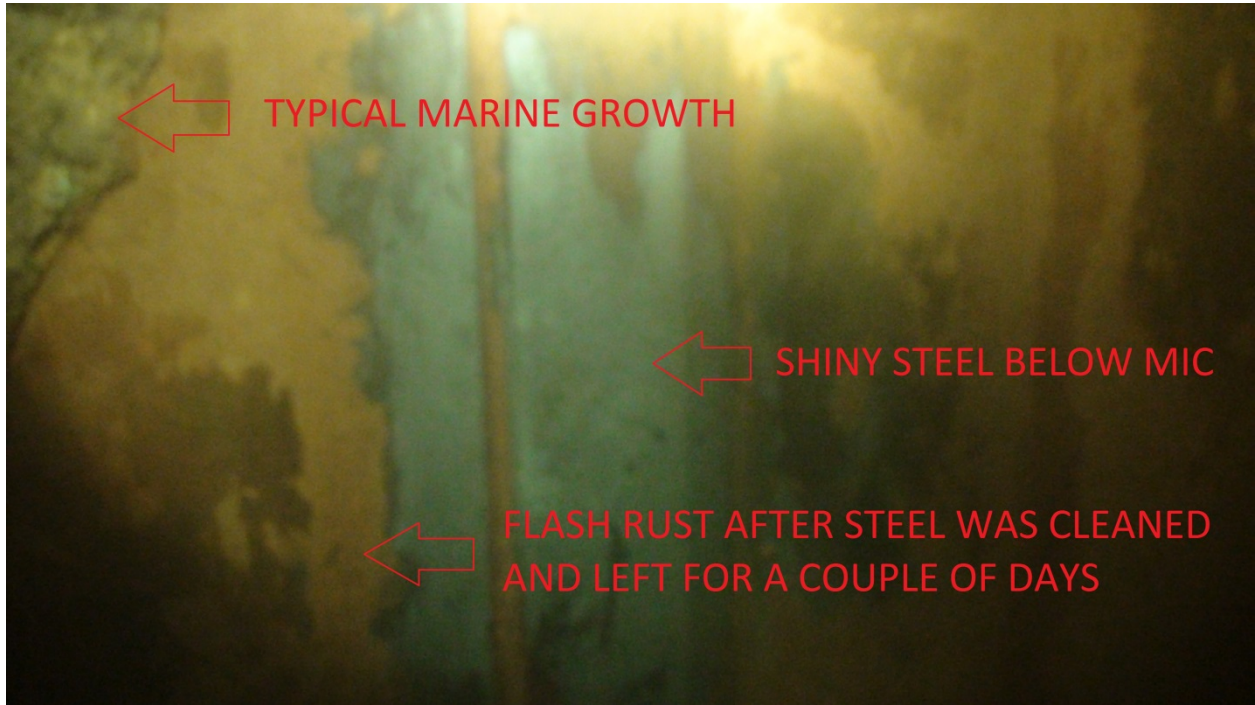
**Photo 3: Typical condition of the SSP.**

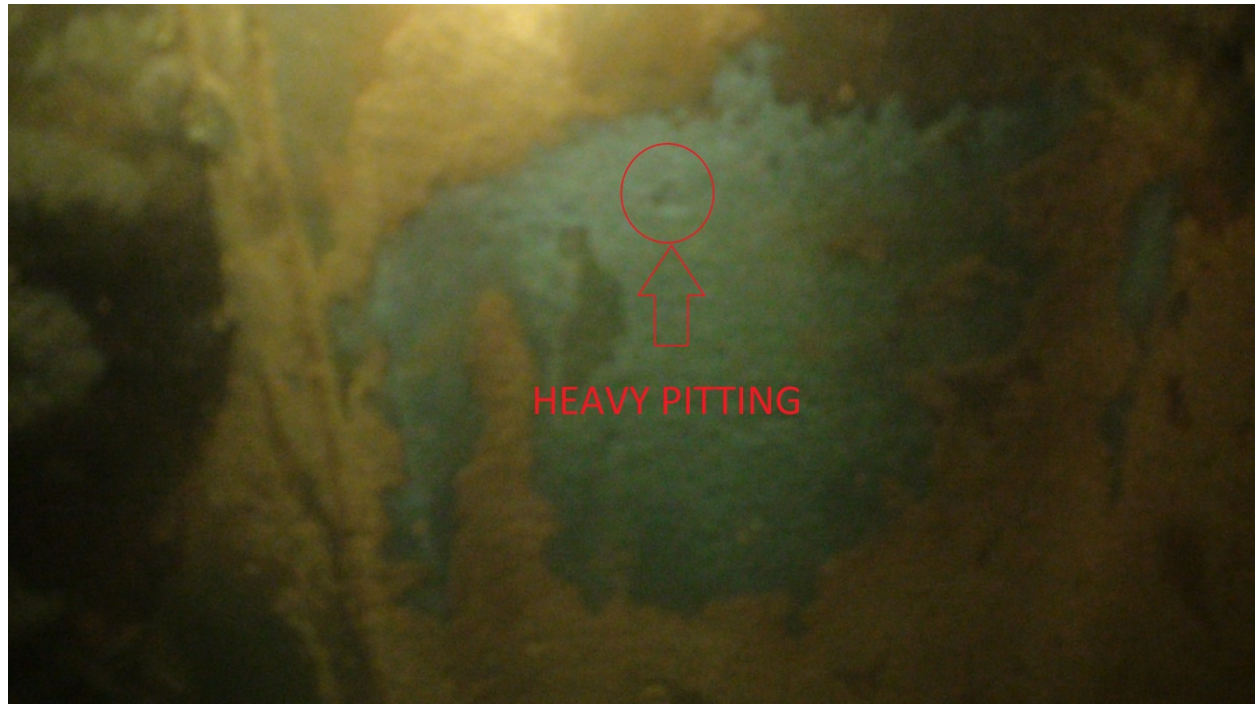
**Photo 4: Heavy pitting on SSP.**

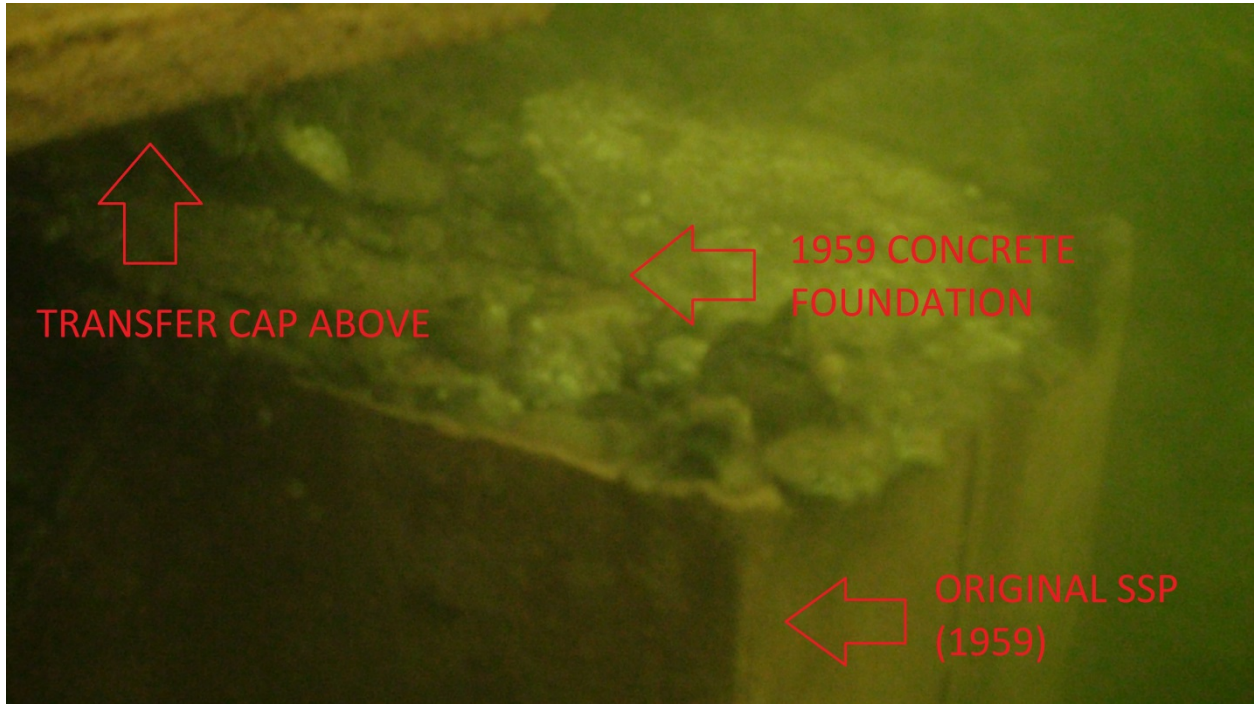
**Photo 7: Typical condition of the concrete between original SSP and transfer cap.**

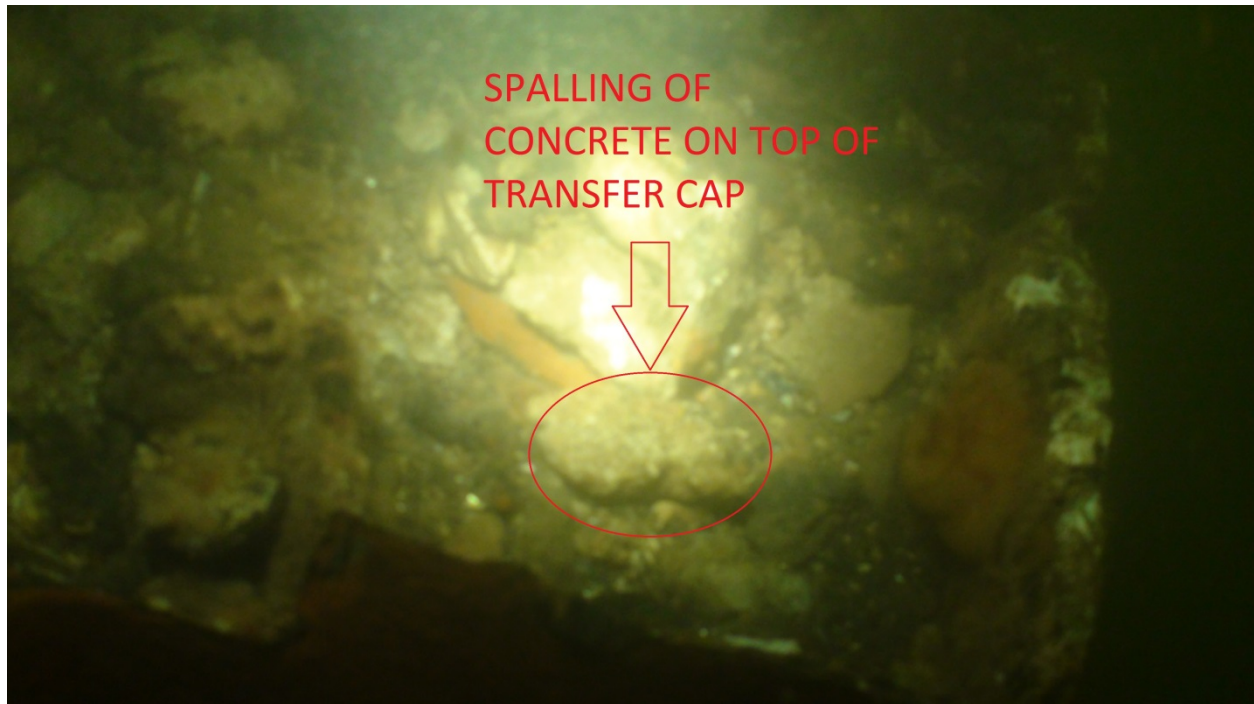
**Photo 8: Spalling of concrete on the top of transfer cap.**

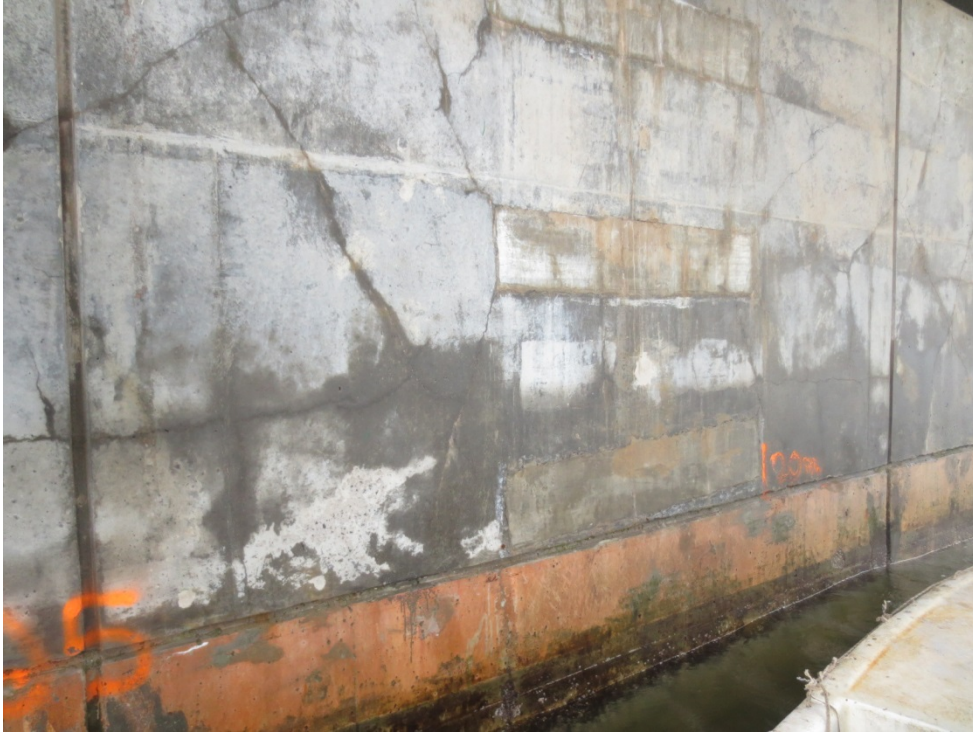
**Photo 9: Typical narrow cracking on pier wall.**

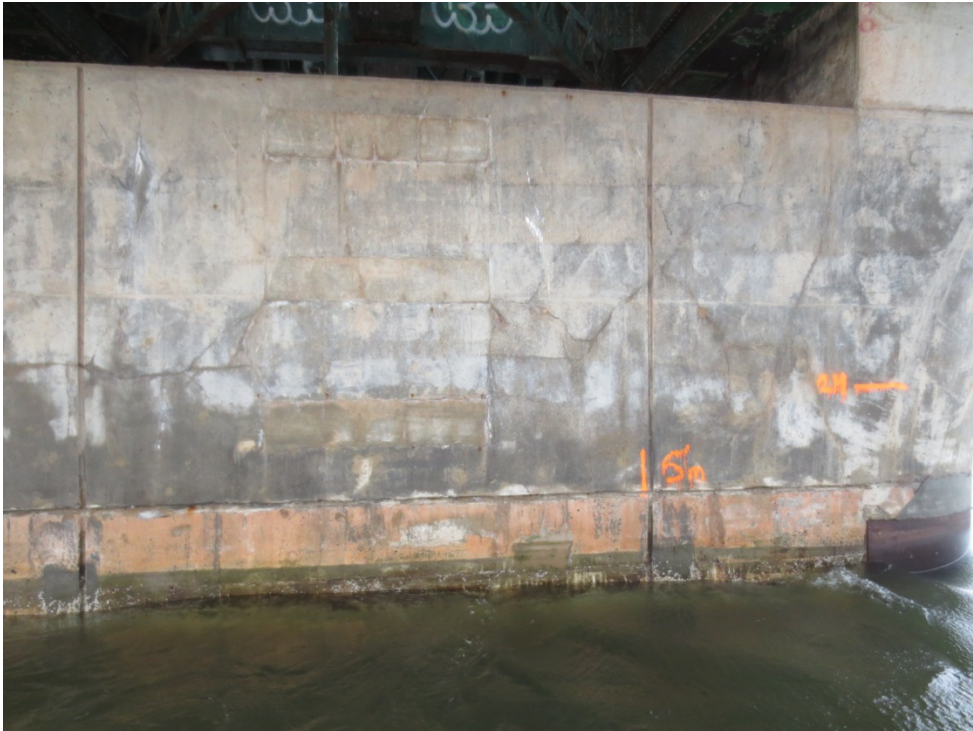
**Photo 10: Typical cracking on pier wall.**

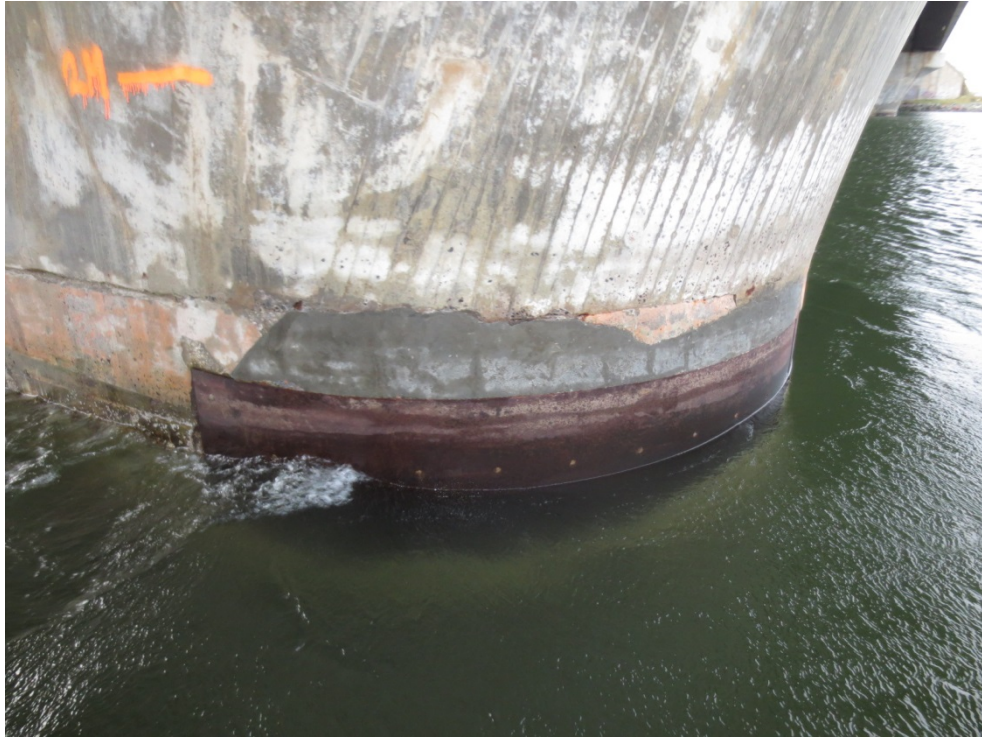
**Photo 11: Repair of concrete above ice shields.**

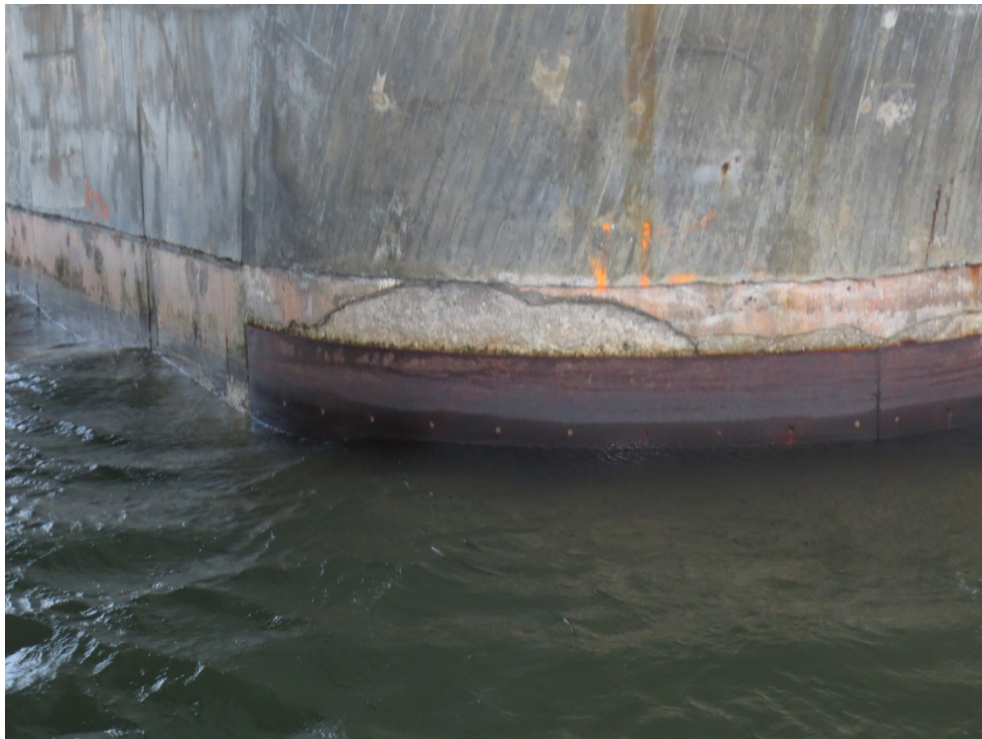
**Photo 12: Typical spalling above ice shields.**

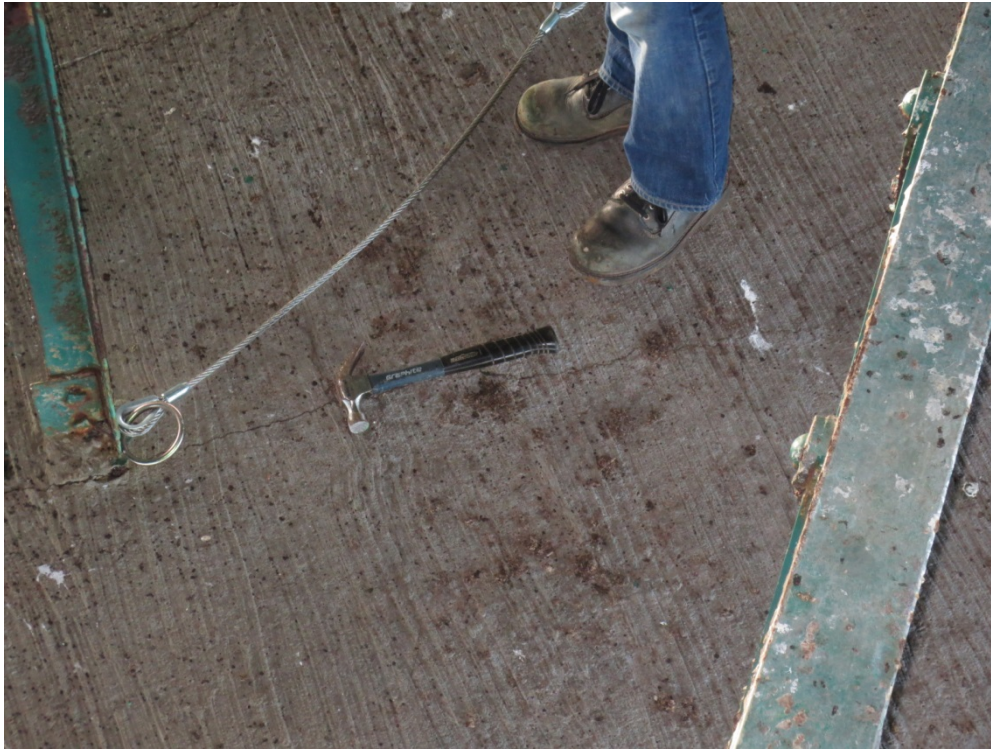
**Photo 13: Transverse cracks between truss bearings.**

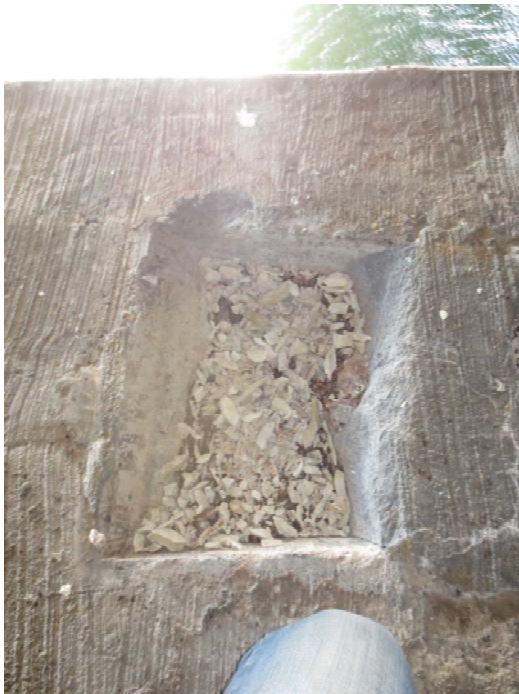
**Photo 14: Spalling of grout in post-tensioning block-out.**

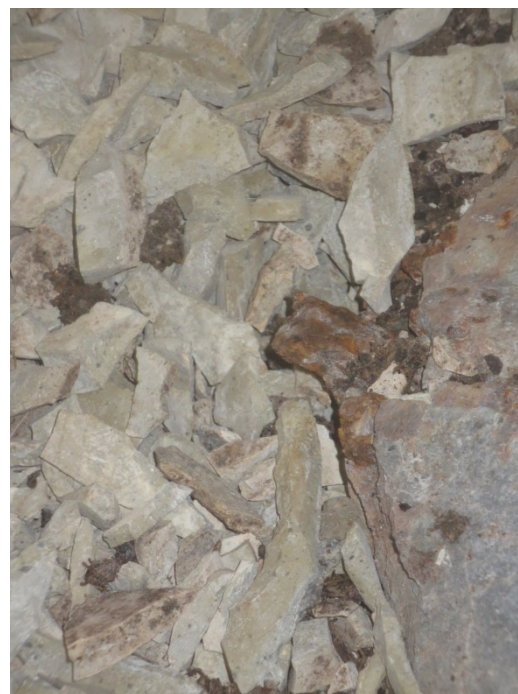
**Photo 15: Exposed PT strand.**

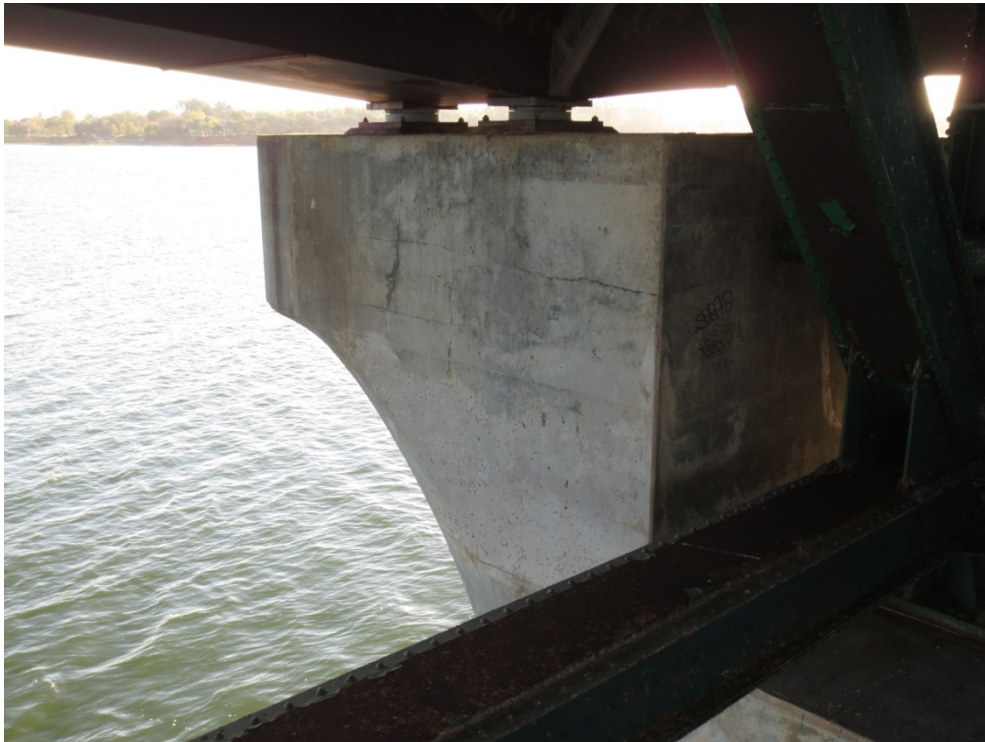
**Photo 17: Narrow cracks below box girders.**
