# Hillsborough Bridge Structural Review

## Final Report

142613.00 • Final Report • January 2016

Prepared for:  
**Prince Edward  
Island Department  
of Transportation  
and Infrastructure  
Renewal**

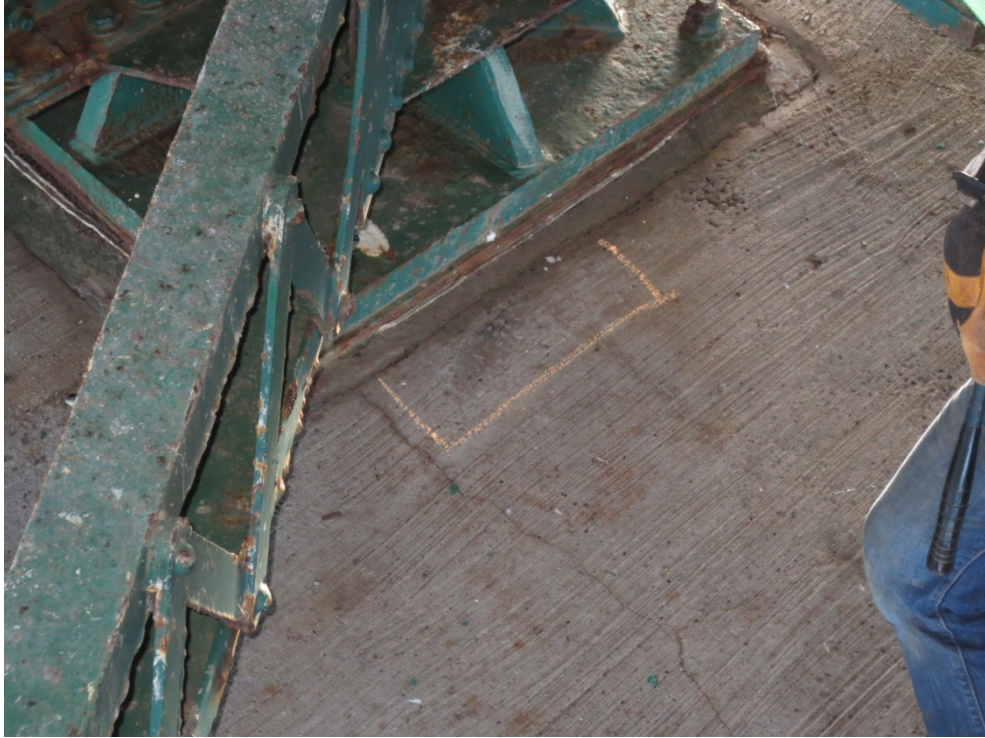
**Photo 16: Delamination adjacent to truss bearing.**
