# Hillsborough Bridge Structural Review

## Final Report

142613.00 • Final Report • January 2016

Prepared for:  
**Prince Edward  
Island Department  
of Transportation  
and Infrastructure  
Renewal**

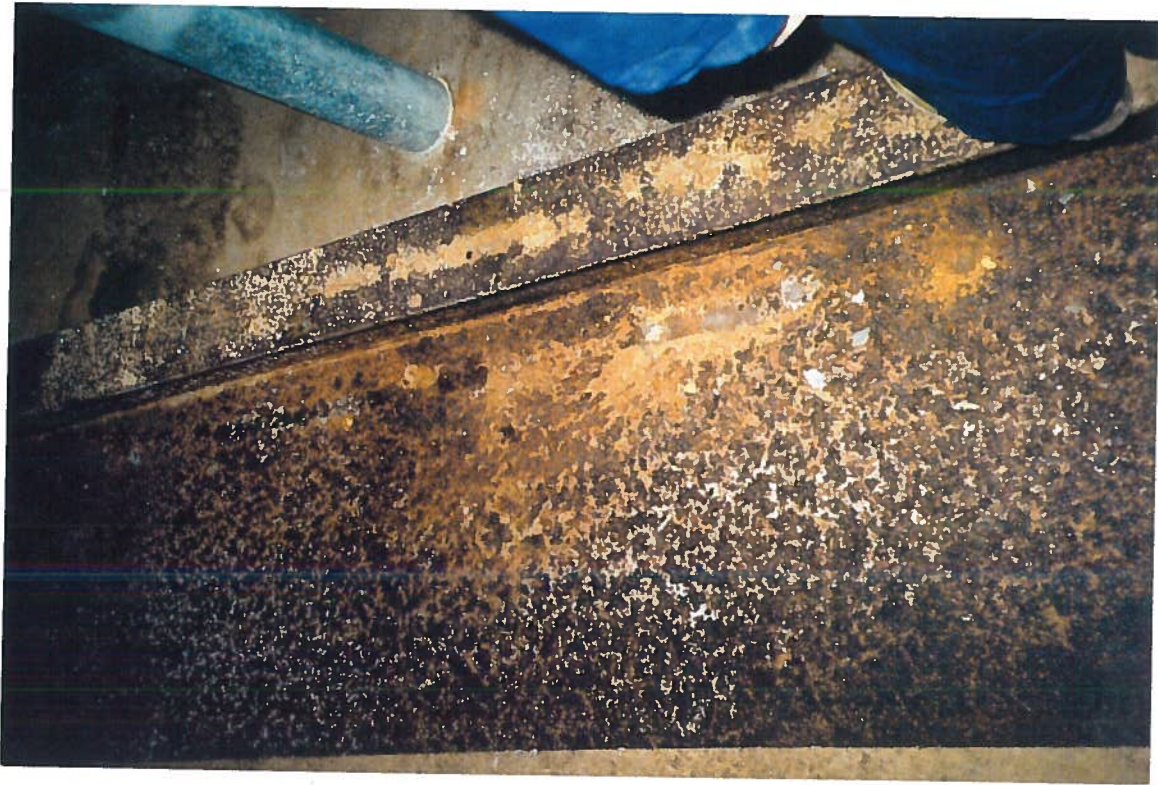
Water at curb face and interior of box

*Interior of box*

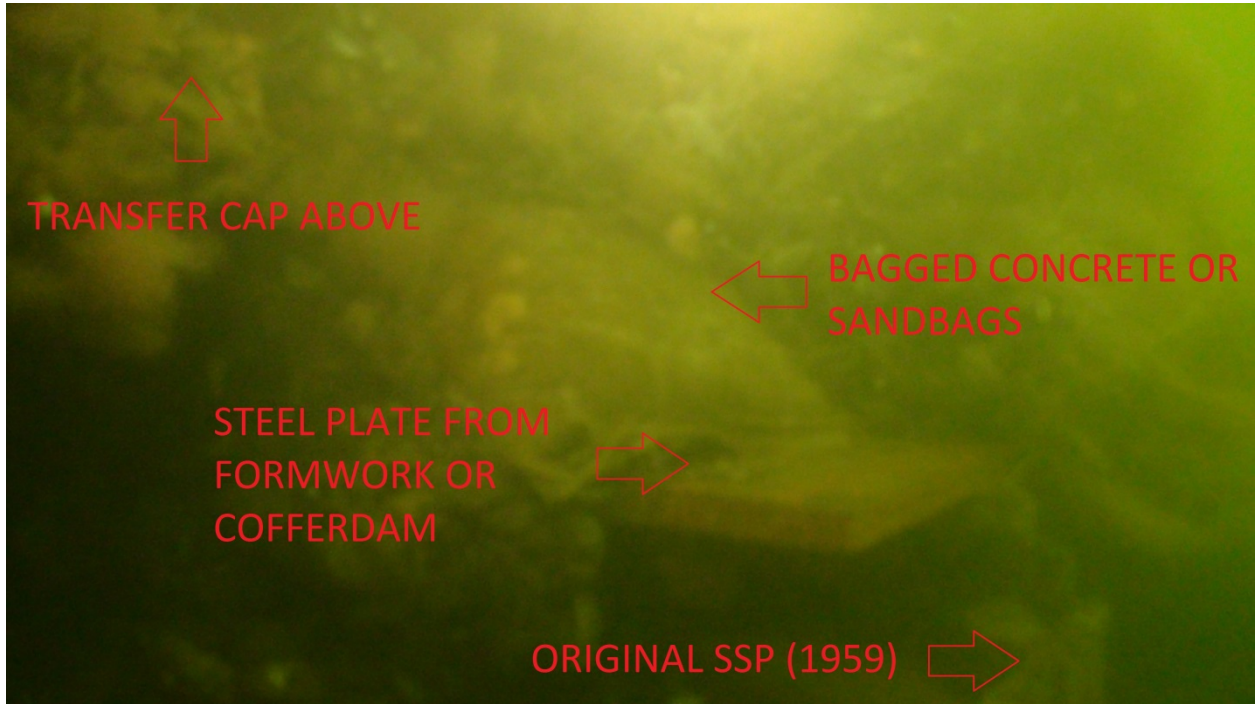
BAGGED CONCRETE OR  
SANDBAGS

**Photo 6: Additional formwork at the base of transfer cap.**
